# KNUEPPEL INSPECTION SERVICES, INC.

## Property Inspection Report

**Prepared For:** CLIENT **SAMPLE REPORT**  
(Name of Client)  
**Concerning:** Home in Fort Bend County  
(Address or Other Identification of Inspected Property)

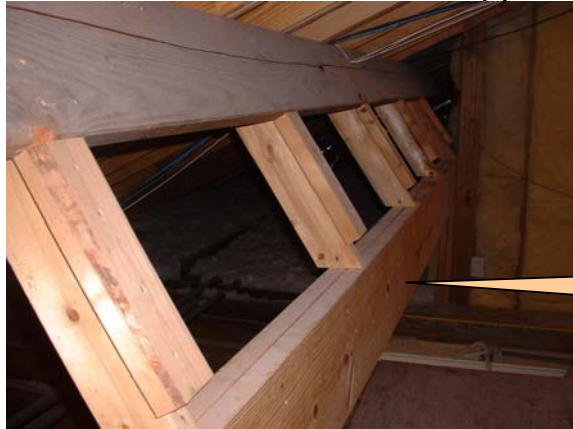
**The purlin brace support beam (2- 2x12's) in garage attic is bowing and needs more lateral support.**

Beam is being pushed sideways.

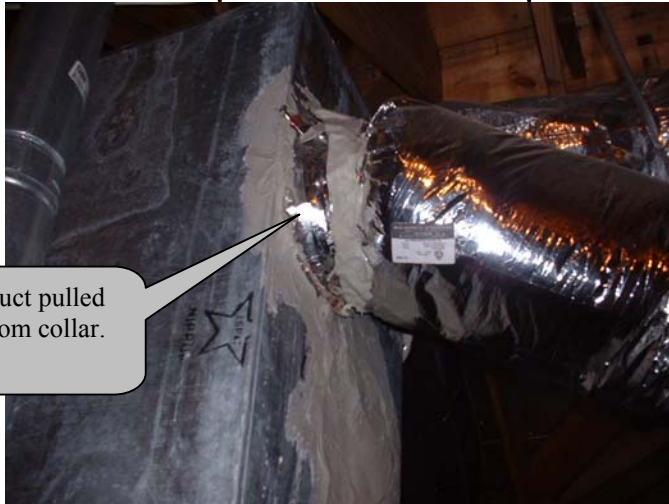
**Air leaks on upstairs unit at the top where duct is attached.**

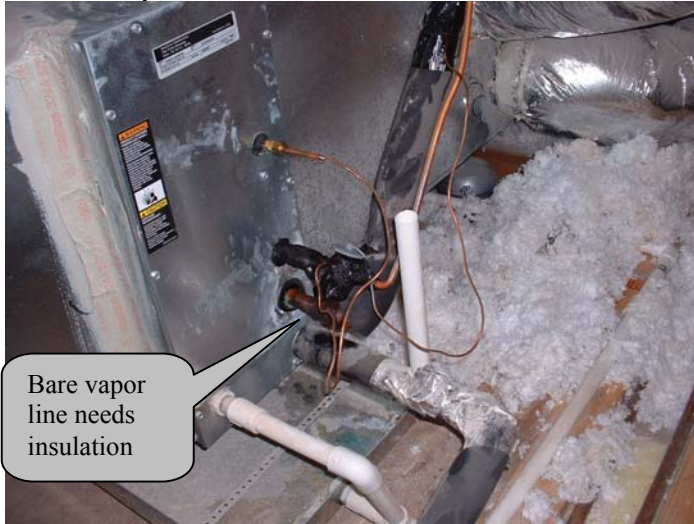
**Vapor line on left side unit needs to be insulated all the way to evaporator coil.**

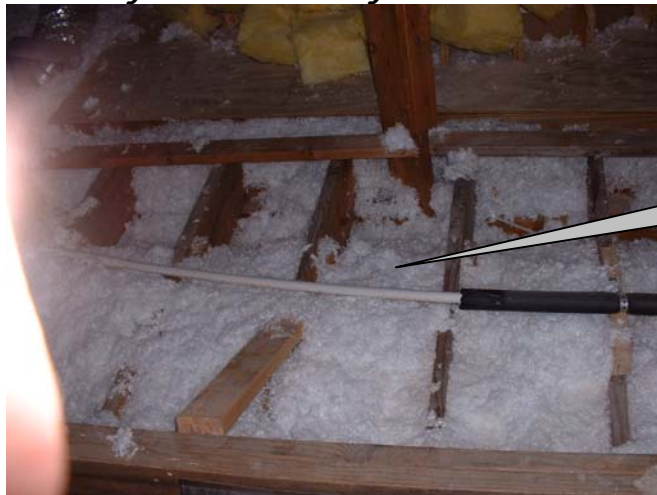
***The condensate drains lines should be insulated all the way to where they are covered by attic insulation.***

Typical of all units.

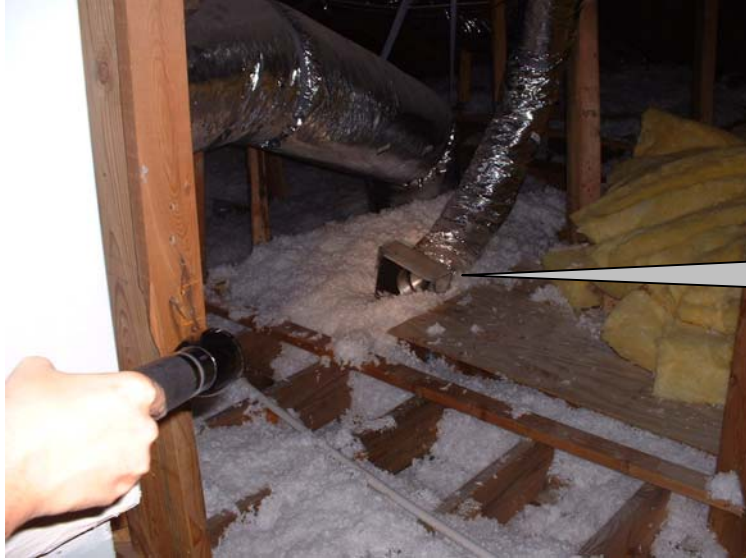
**There is an air register lying in the right attic by raised entry. It appears that it should be installed in the entry area.**

Air register not installed

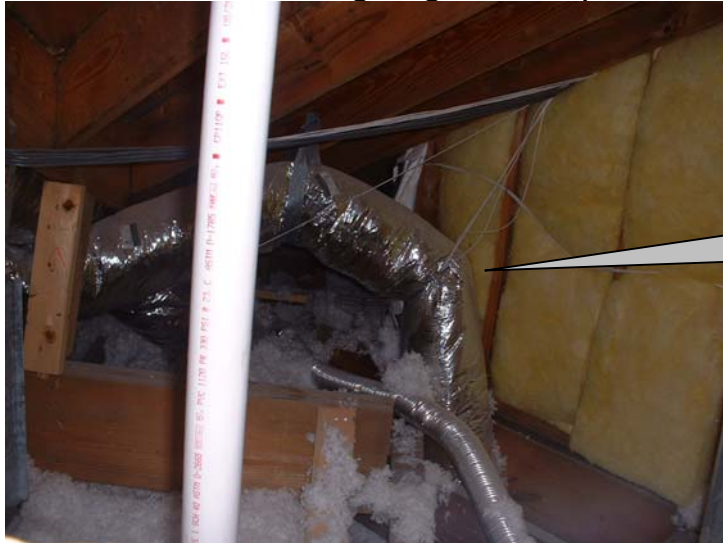
**Air duct on left side in garage attic is pinched. See below.**

Air duct appears to be restricted
